NASA Contractor Report 159261

VISUALIZATION OF IMPACT DAMAGE OF COMPOSITE
PLATES BY MEANS OF THE MOIRÉ TECHNIQUE

W. G. Knauss, C. D. Babcock,
and H. Chai

NASA Grant NSG-1483
April 1980

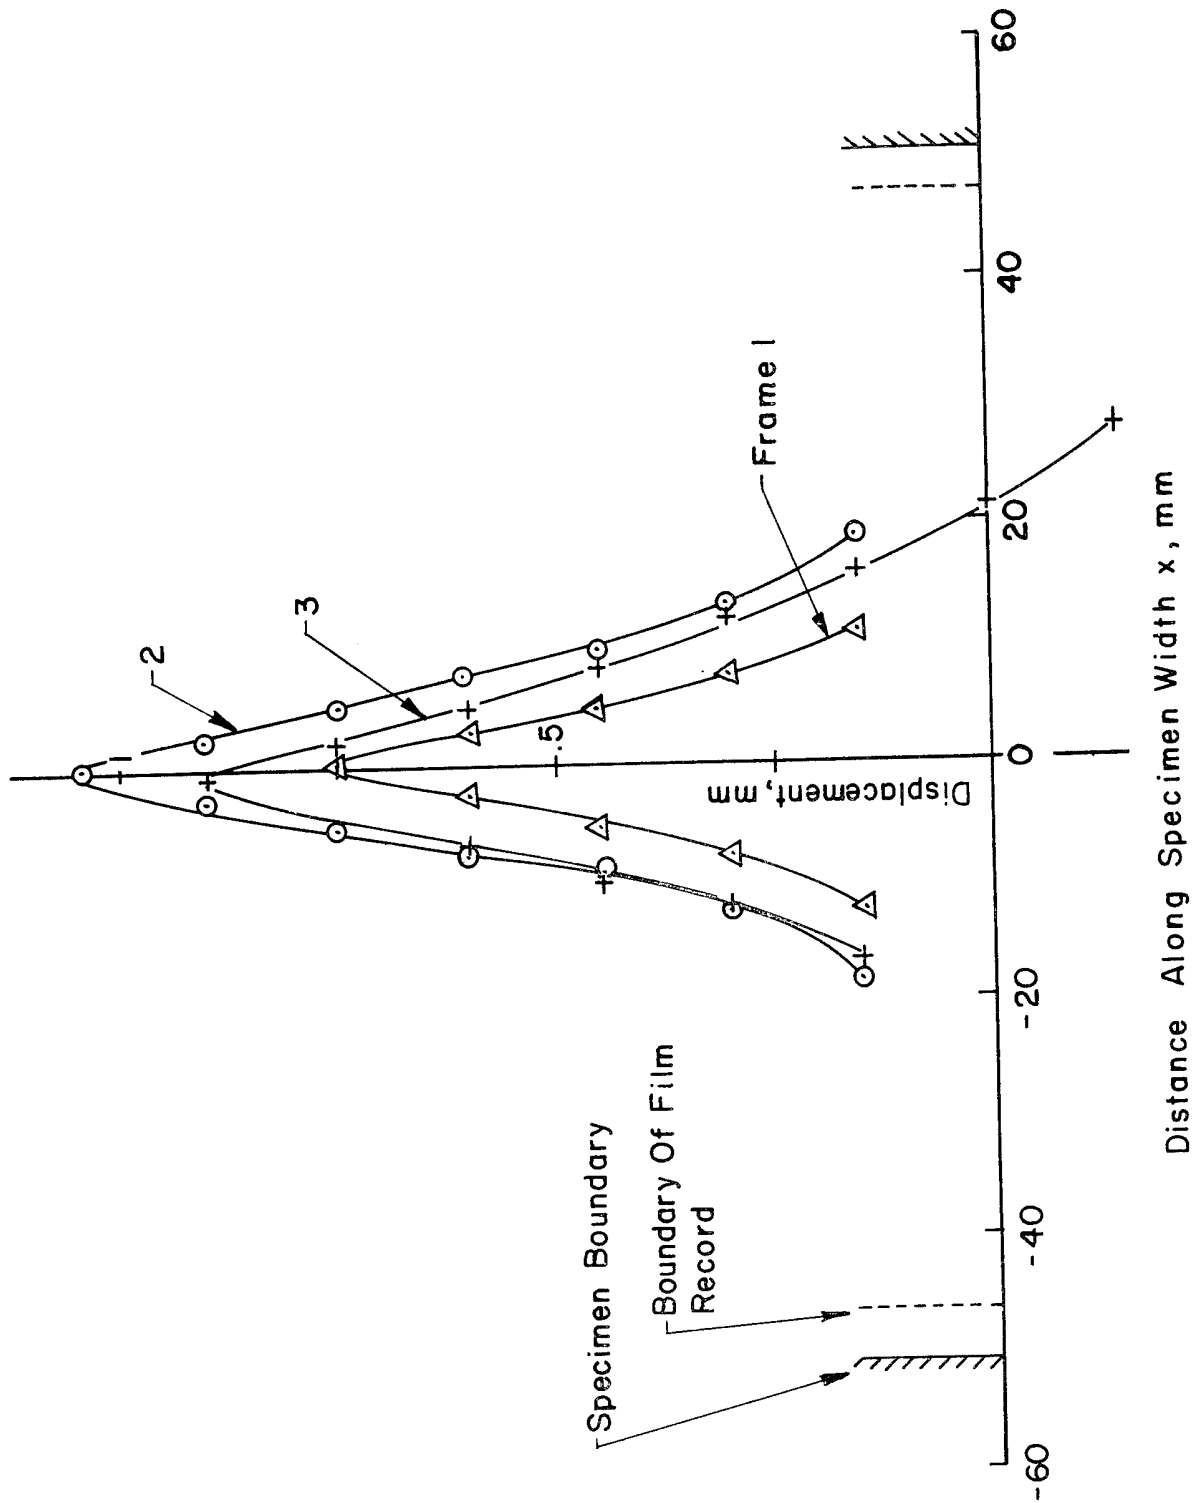
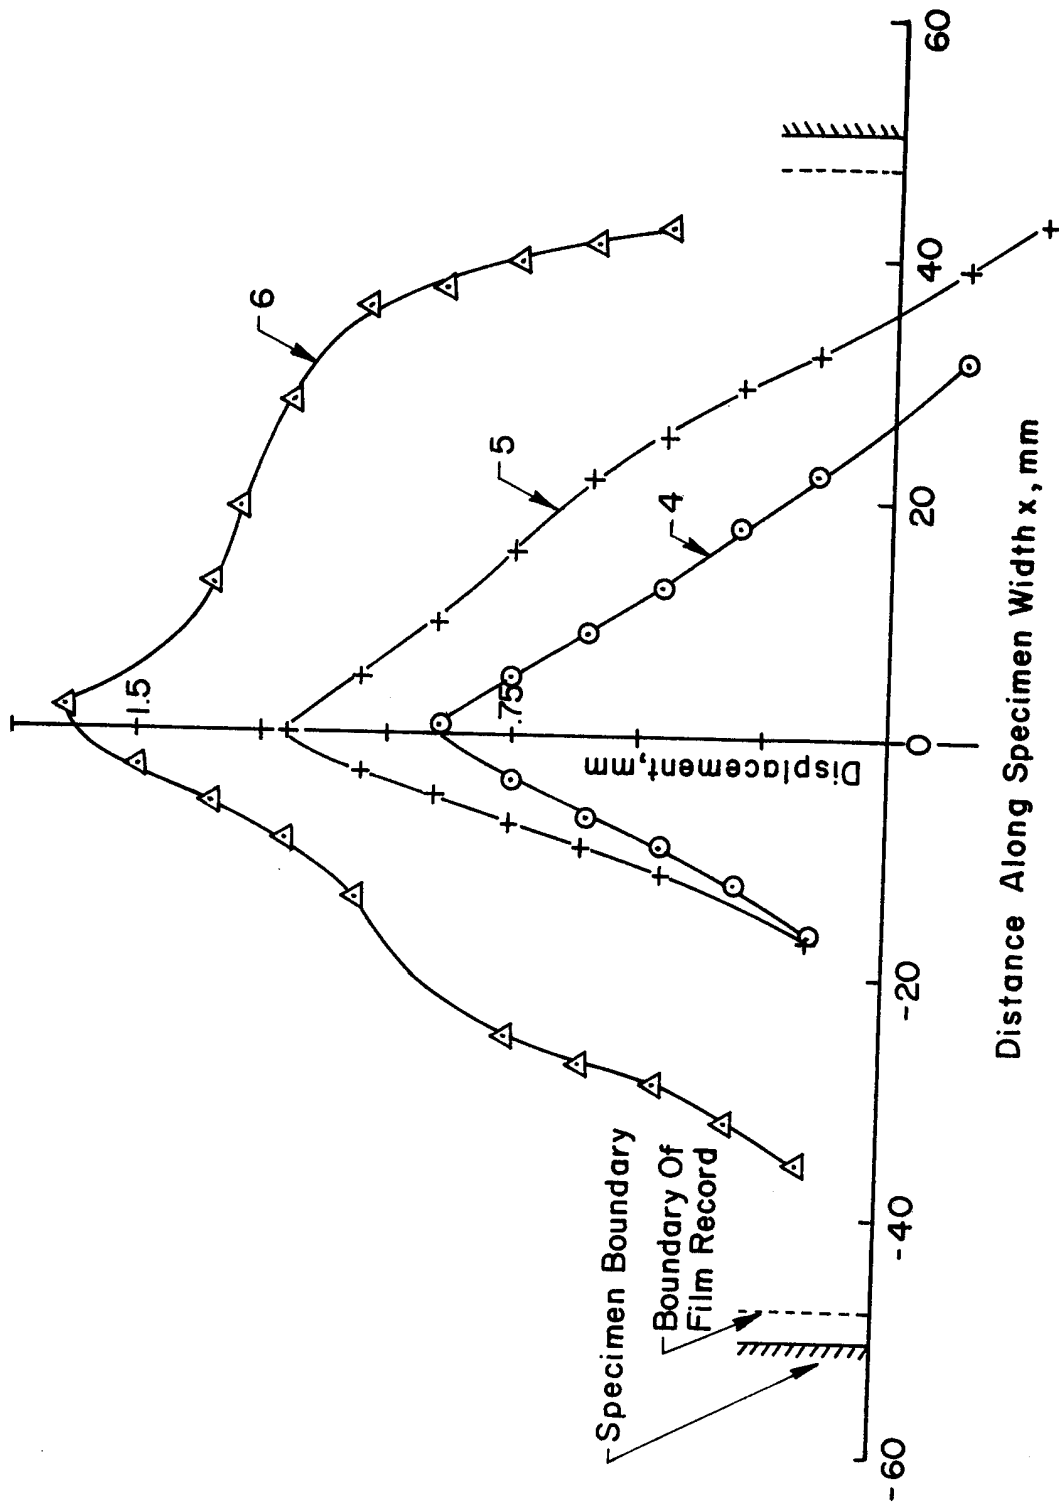
FIG. 17 TEST PANEL B-9 OUT OF PLANE DISPLACEMENT ALONG SPECIMEN WIDTH
(time interval between frames - $50.25 \mu s$)

The contours of surface displacements can be converted to displacements and displayed as displacement versus distance plots. This type of result is shown in fig. 17 for test panel B-9. The time between frames is approximately 50 μ s. The rapid spreading of the damage is evident after frame 4. The velocity of this spreading will be discussed in the next section.

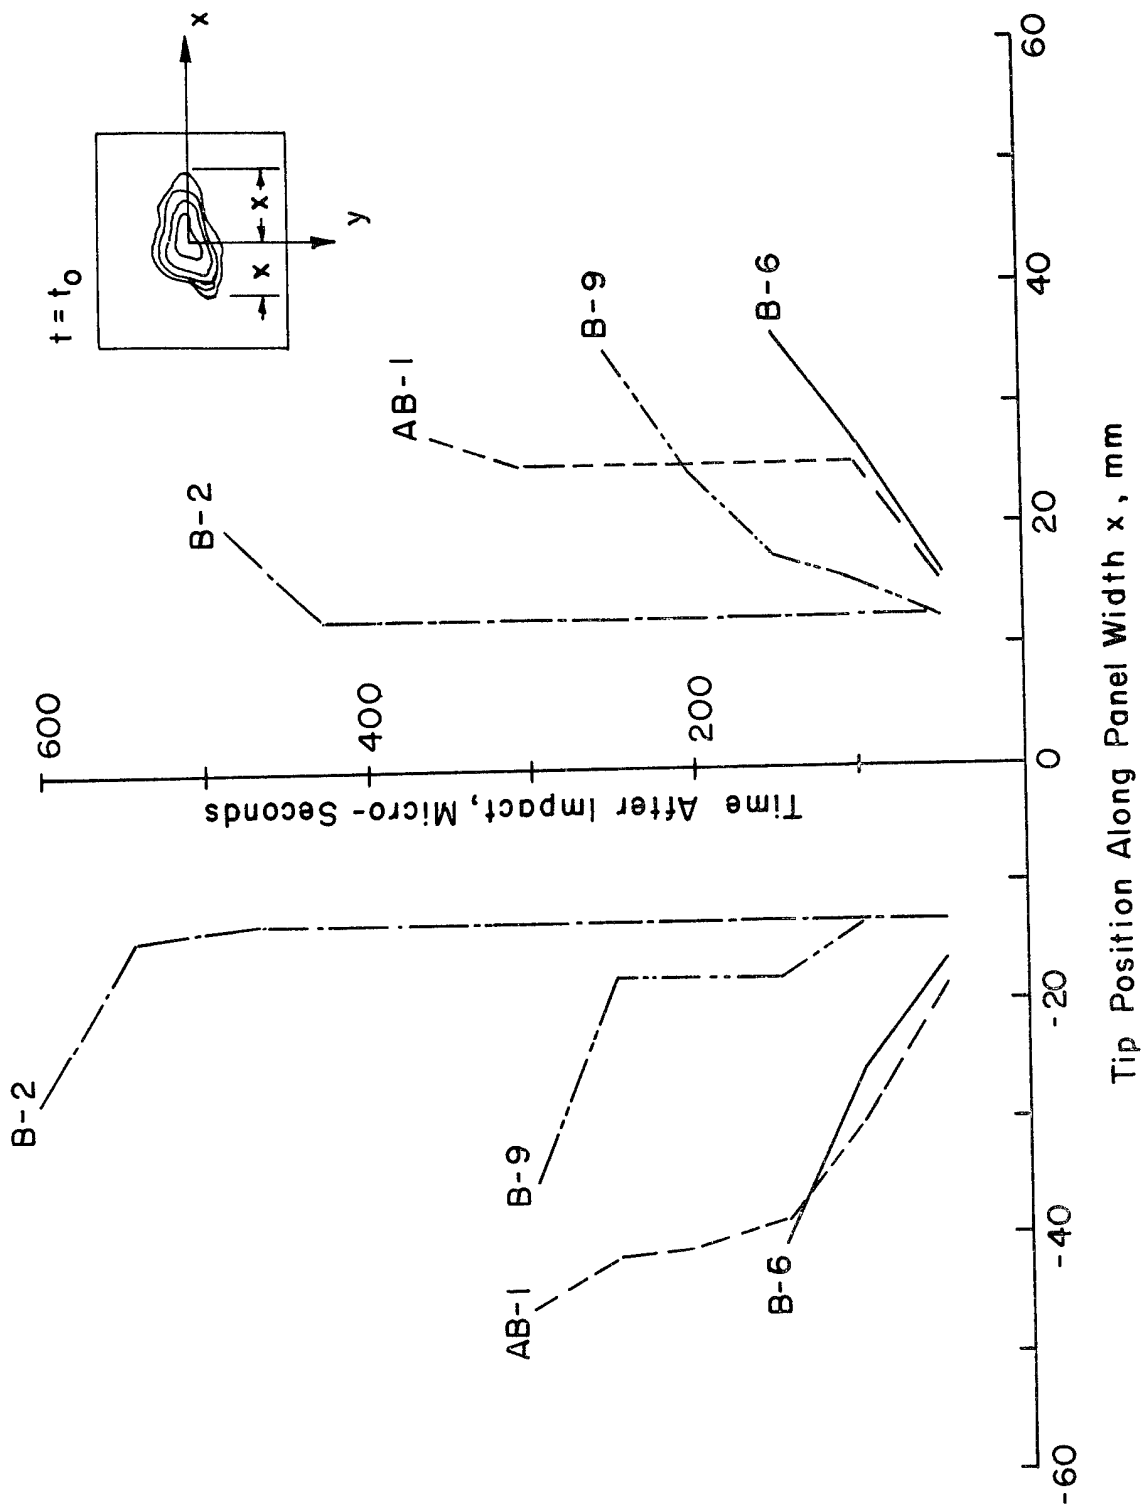
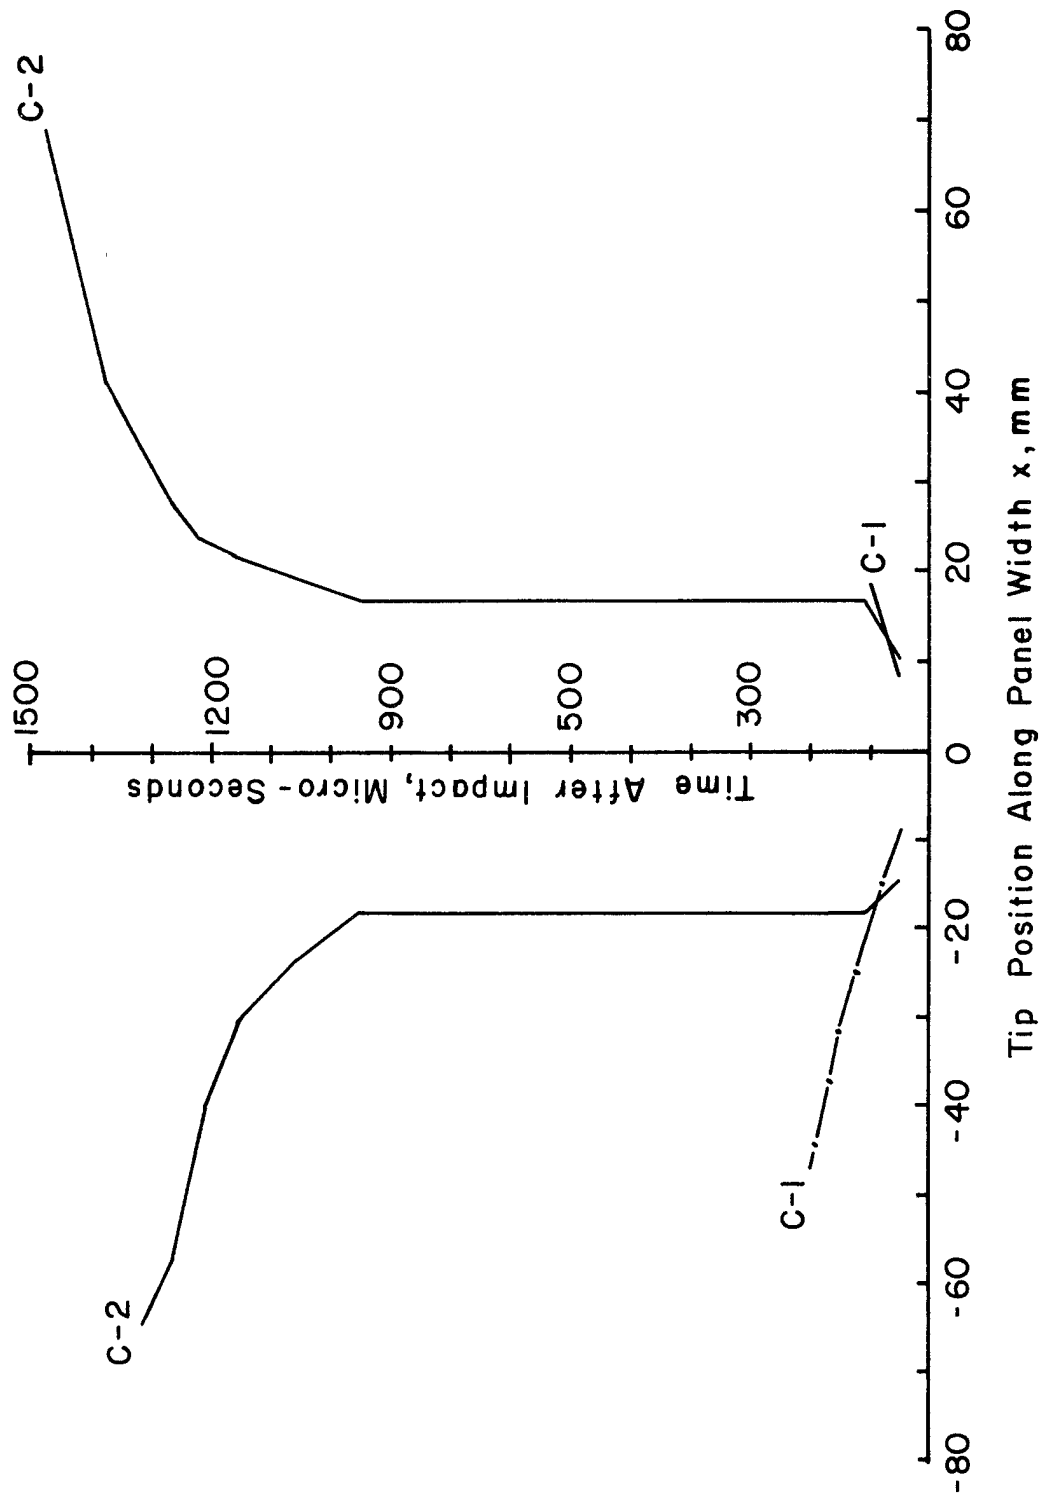
FIG.18 DELAMINATION TIP POSITION ALONG PANEL WIDTH AS FUNCTION OF TIME

Having commented on the time history of the delamination spreading, it is of interest to indicate an estimate of the rate at which this spreading occurs. This information can be directly found using fig. 18. From this figure it was deduced that the maximum velocity falls in the range of 1.4×10^3 m/sec to 3.3×10^3 m/sec. The average value of this maximum was 1.9×10^3 m/sec (7500 in/sec). While this velocity is substantial it is slow compared to a typical in-plane wave velocity for this material.
